Technical Bulletin

TB5013

General Motors Front Brake Pedal Pulsation

**Subject: Front Disc Brake Pulsation
(New Rotor Run-Out Specification and Correction Method)**

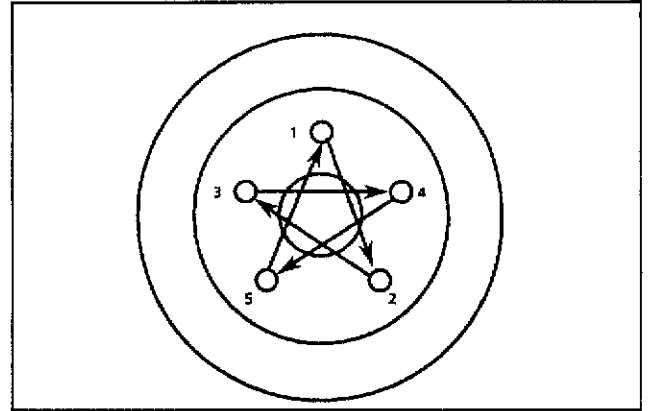
70082

Important: It is critical to follow the procedure below for torquing the wheels. Brake rotors may be distorted if the wheel nuts are tightened with an impact wrench or if this procedure is not followed exactly.

- Hand tighten all 5 wheel nuts using the star pattern (refer to the illustration).
 - Tighten all 5 wheel nuts to approximately 1/2 specification using the star pattern.

- Tighten all 5 wheel nuts to 140 N·m (100 lb ft) using the star pattern.
12. Fasten a dial indicator to the steering knuckle so that the indicator needle contacts the rotor inboard friction surface approximately 12.7 mm (0.5 in) from the rotor's outer edge.
